ISSUE 29 - APR-MAY-JUN 90

SECTION 3 - AMIGA

-
- 29/3-0.0 INDEX - AMIGA SECTION TECHTOPICS ISSUE 29.
 - 29/3-1.1 A2091 MEMORY AUTO-CONFIGURATION LIMITATIONS.
 - 29/3-2.1 A2091 IC MEMORY 262,144 ADDRESS X 4 BIT DRAM.

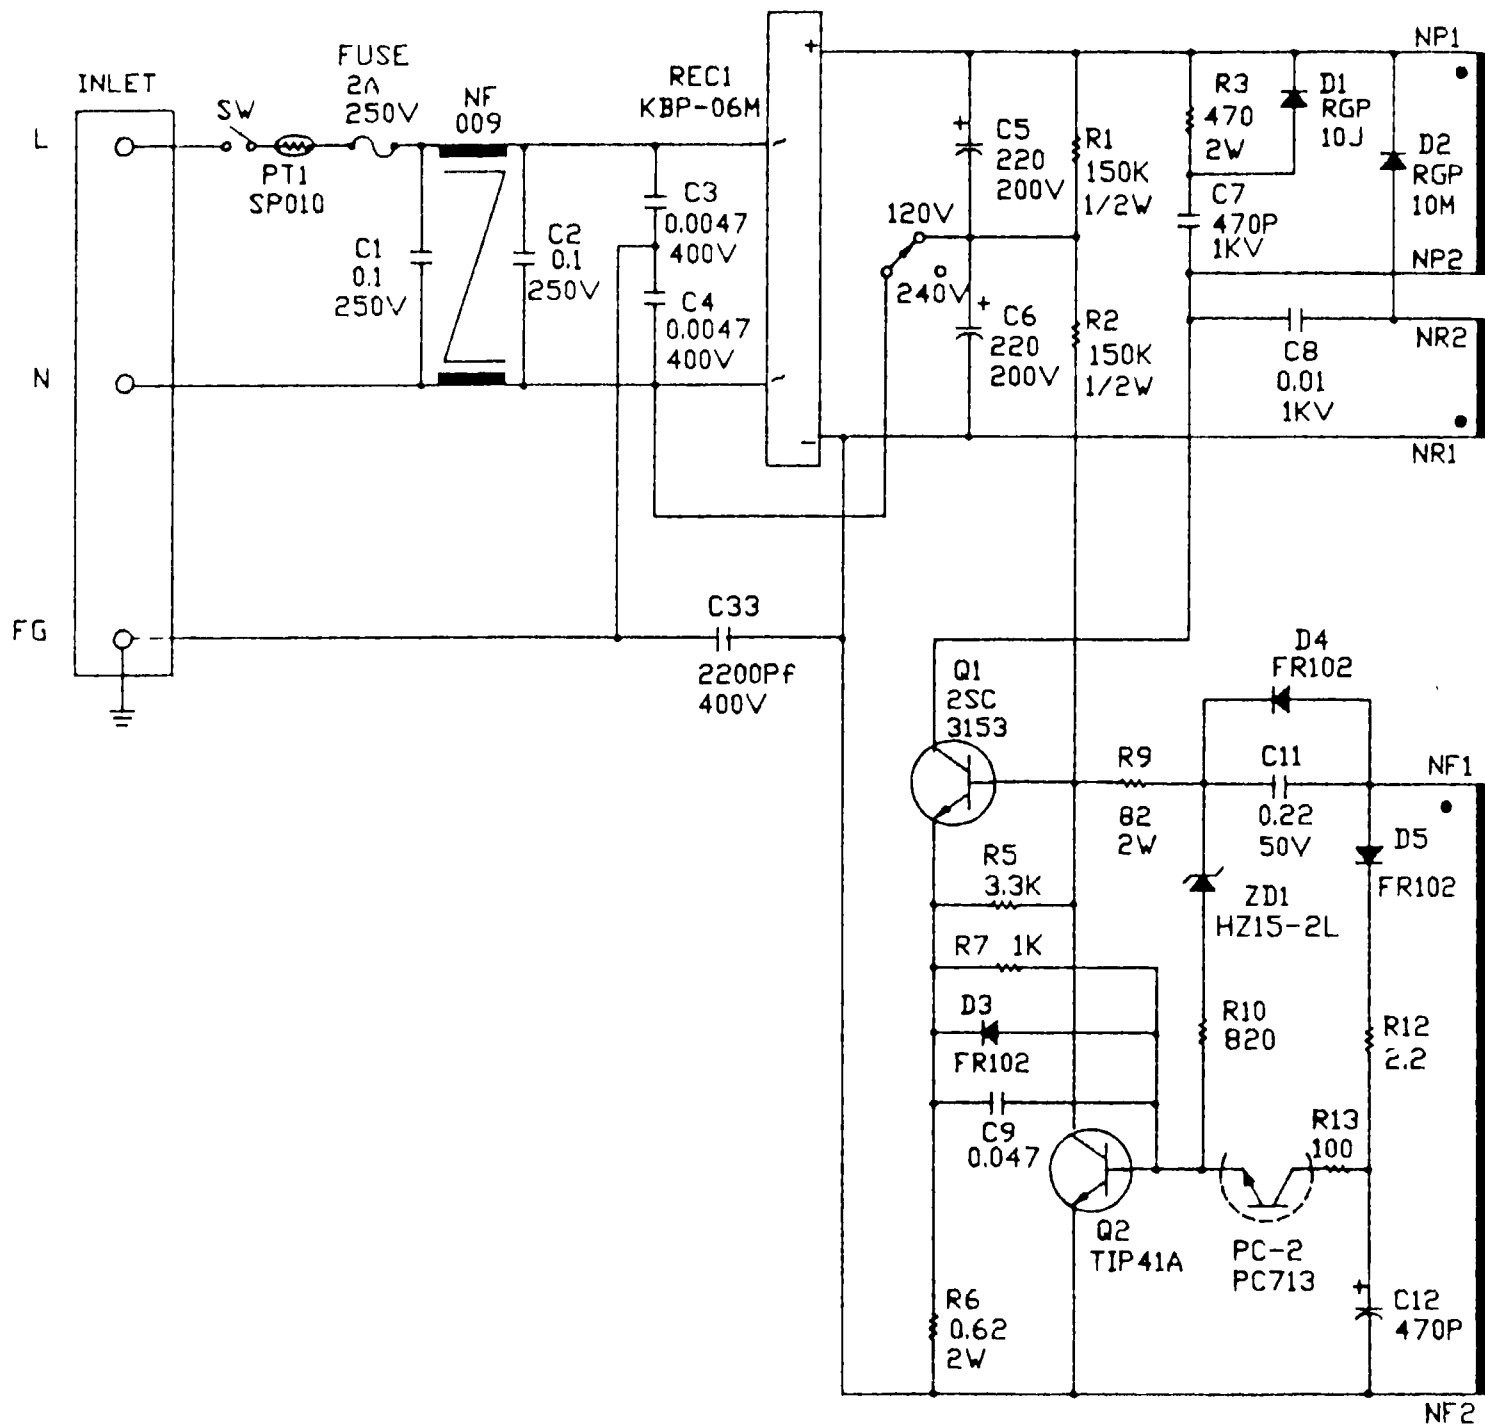
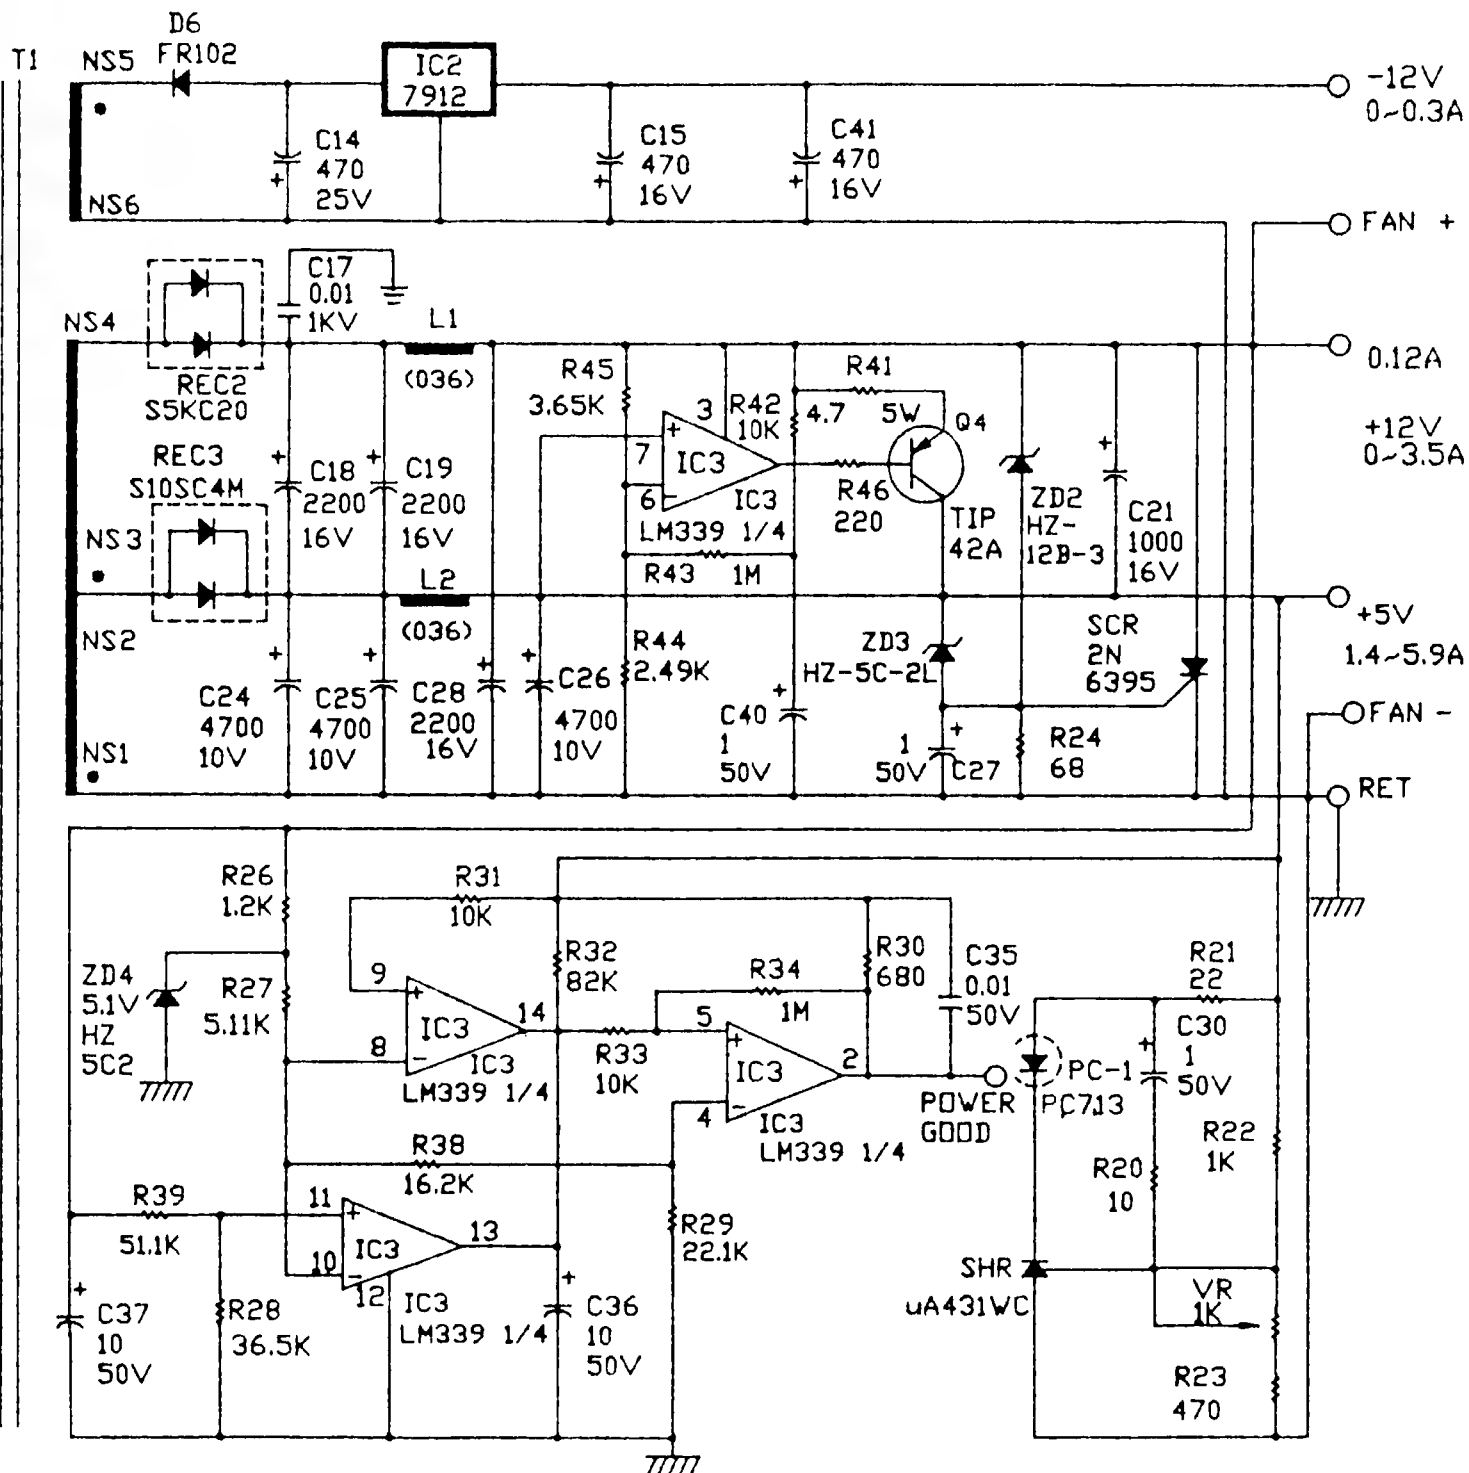
PC10-III POWER SUPPLY
Assembly #312637-02

OEM SCHEMATIC FOR PC10-III POWER SUPPLY ASSY #312637-02 IS FOR REFERENCE ONLY. NO WARRANTY COMPONENT REPAIRS ARE AUTHORIZED FOR THIS ASSEMBLY.

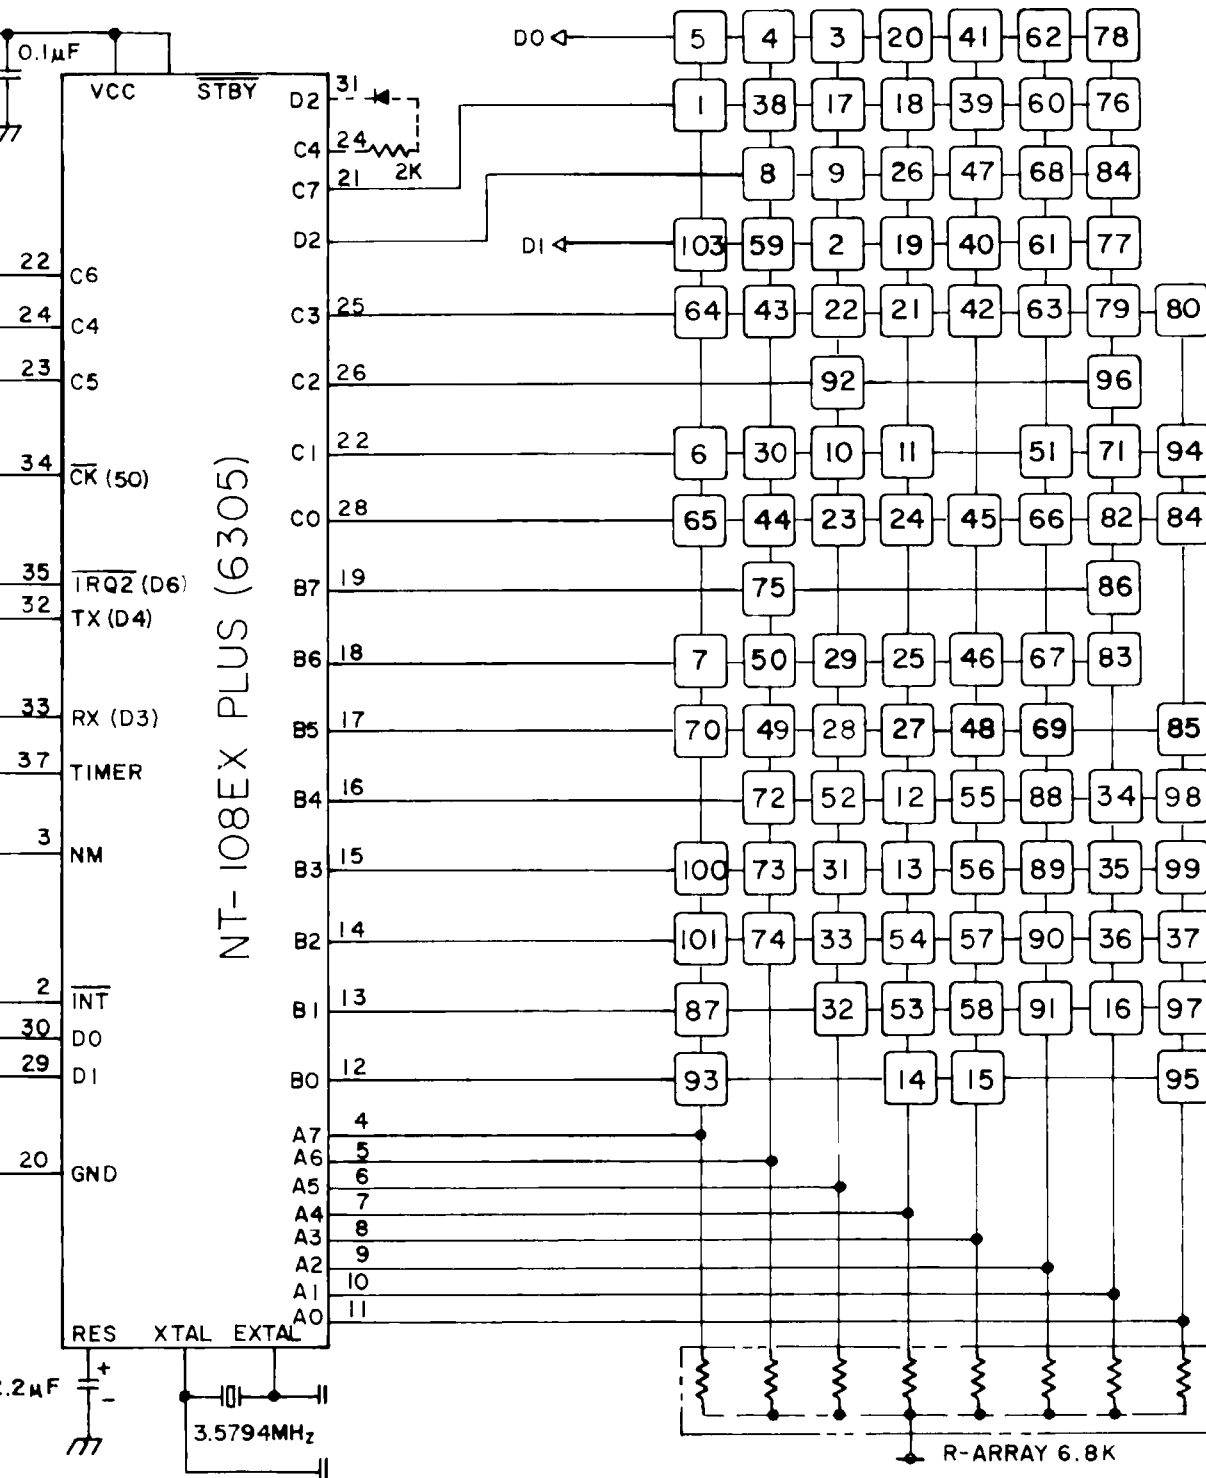
PC10-III KEYBOARD Assembly #312702-02

OEM SCHEMATIC FOR PC10-III KEYBOARD ASSEMBLY # 312702-02 IS FOR REFERENCE ONLY. NO WARRANTY COMPONENT REPAIRS ARE AUTHORIZED FOR THIS ASSEMBLY.
